**Flood Control Project Maintenance  
Levee Inspections**

**Fall 2019 Levee Maintenance Deficiency Summary Report**

**Sacramento River Basin**

**Lake County Watershed Protection District**

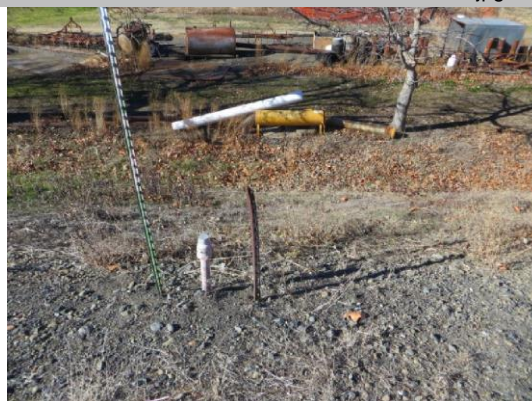
Photo 1 of 3 : UCIP\_FA\_2019\_55865\_51250.jpg

Comment Code						
Inspector Comment						
DS_ID:21214 FS_ID:55865 EP_NO: 15825 Repair Type: Non-Urgent Crossing Status: Found UCIP Comments: 10/23/2019 Record remains Non-Urgent, pipe appears to be abandoned; need to audit record to confirm owner. Pipe owner has sealed WS pipe. The UCIP inspection was completed with DWR Inspector, L. Dial, and LMA representative, S. Webb. (O. Magana - DWR UCIP)01/22/2014 Pipe with closure device not visible on WS toe. Clear soil from pipe and cover for better verification of closure. (W. Wylie - DWR UCIP) FIELD_STRUCT_DESC: 8-inch steel irrigation pipe through the levee, 2 feet below the crown. Siphon breaker on apex of pipe at the landside (LS) shoulder. Exposed filter on LS slope. Seasonal pump on the waterside (WS) slope. (10-inch pipe authorized under Permit No. 15825, 1992 - Edward Seely, 8-inch pipe installed instead of 10-inch pipe per inspector's notes dated 9-25-92). [Additional Reference(s): DWR Levee Log, 2005]. FS Date: 10/23/2019 1:18:00 PM

Vent on LS shoulder with filter visible on LS toe.

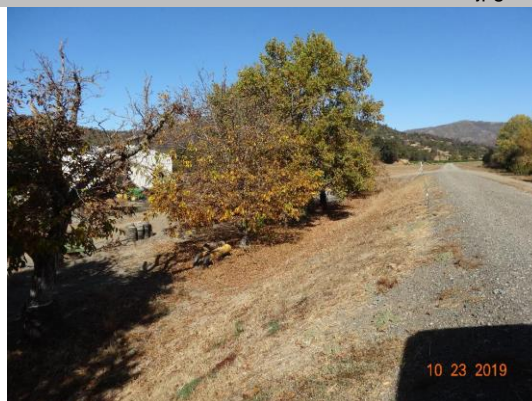
Photo 3 of 3 : UCIP\_FA\_2019\_55865\_82644.jpg

Comment Code						
Inspector Comment						
DS_ID:21214 FS_ID:55865 EP_NO: 15825 Repair Type: Non-Urgent Crossing Status: Found UCIP Comments: 10/23/2019 Record remains Non-Urgent, pipe appears to be abandoned; need to audit record to confirm owner. Pipe owner has sealed WS pipe. The UCIP inspection was completed with DWR Inspector, L. Dial, and LMA representative, S. Webb. (O. Magana - DWR UCIP)01/22/2014 Pipe with closure device not visible on WS toe. Clear soil from pipe and cover for better verification of closure. (W. Wylie - DWR UCIP) FIELD_STRUCT_DESC: 8-inch steel irrigation pipe through the levee, 2 feet below the crown. Siphon breaker on apex of pipe at the landside (LS) shoulder. Exposed filter on LS slope. Seasonal pump on the waterside (WS) slope. (10-inch pipe authorized under Permit No. 15825, 1992 - Edward Seely, 8-inch pipe installed instead of 10-inch pipe per inspector's notes dated 9-25-92). [Additional Reference(s): DWR Levee Log, 2005]. FS Date: 10/23/2019 1:18:00 PM

LS view: overview of LS.

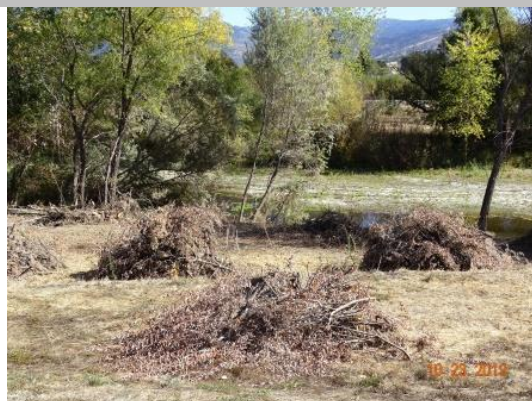
Photo 1 of 1 : FA\_2019\_NA0009\_4\_28\_20191024\_00051.jpg

LM Start	1.95	Rating **	M	Issue No.	28
LM End	1.95	Issue Type +	En	Location *	WS
Category	Earthen Levee			GPS Latitude/Longitude	
				Start	End
Item	Encroachments			39.163548 °	39.163548 °
				-122.916730 °	-122.916730 °
DWR ID	DWR_NA0009_02_f_2019_28				
Comment Code					
PR : Prunings					
Inspector Comment

View of prunings on the waterside berm. Fall 2019

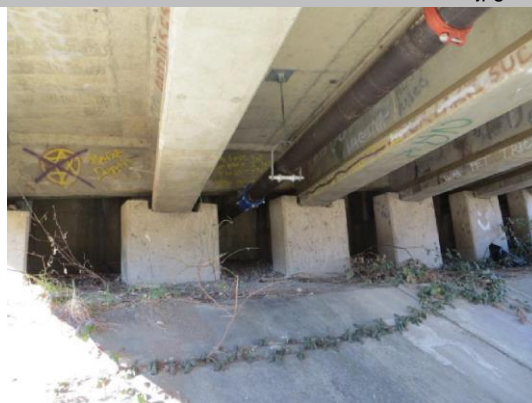
Photo 1 of 3 : UCIP\_FA\_2019\_55752\_51263.jpg

Comment Code						
Inspector Comment						
DS_ID:21243 FS_ID:55752 EP_NO: 15865 Repair Type: Non-Urgent Crossing Status: Found UCIP Comments: 10/23/2019 Record remains Non-Urgent, unable to confirm alignment; permit recordation notes pipe was never installed from 1983 to 1999 due to property litigation. 03-10-1999 permit owner requested permit stay active. Recommend auditing permit to confirm if pipe was ever installed. (O. Magana - DWR UCIP)01/22/2014 Permit number likely revised from 15865. Verify with inspector and modify entry as required. (W. Wylie - DWR UCIP) FIELD_STRUCT_DESC: 6-inch polyvinyl chloride pressurized sewer line through the levee, 3 feet below the crown. Cutoff wall around pipe at center of levee. Sanitary Sewer manhole on the waterside (WS) shoulder. (6-inch pipe authorized under Permit No. 15865, 1992 - Zachary Calhoun). FS Date: 10/23/2019 1:19:00 PM

Pipe visible under bridge.

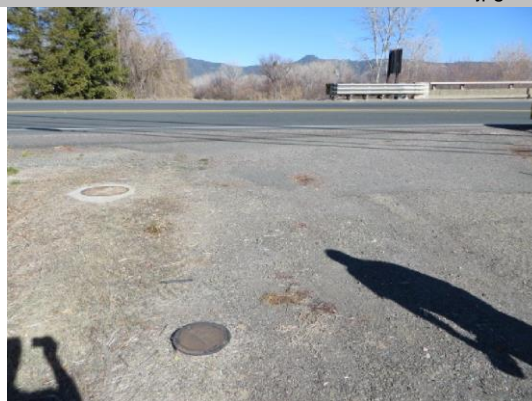
Photo 2 of 3 : UCIP\_FA\_2019\_55752\_51262.jpg

Manhole and vent lids visible on LS shoulder.

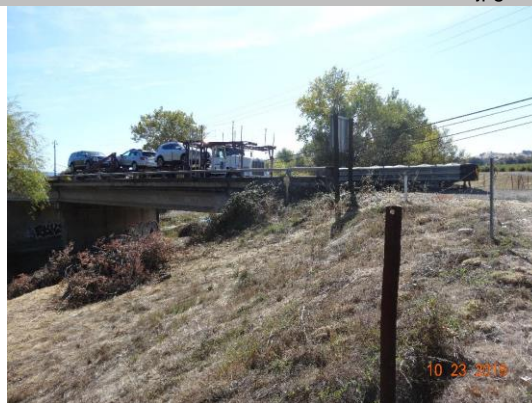
Photo 3 of 3 : UCIP\_FA\_2019\_55752\_82685.jpg

WS view: bridge where pipe is suspended from.

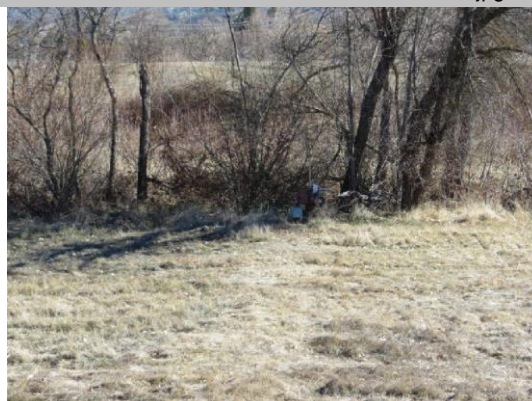
Photo 1 of 3 : UCIP\_FA\_2019\_55753\_51274.jpg

Comment Code						
Inspector Comment						
DS_ID:21245 FS_ID:55753 EP_NO: 17191 Repair Type: Non-Urgent Crossing Status: Found UCIP Comments: 10/23/2019 Record has been updated from No Action Needed to Non-Urgent, pipe appears to be abandoned; need to audit record to confirm owner. The UCIP inspection was completed with DWR Inspector, L. Dial, and LMA representative, S. Webb. (O. Magana - DWR UCIP) FIELD_STRUCT_DESC: 1 of 2: 8-inch coated steel irrigation pipe through the levee, 2 feet below the crown. Well and electric pump at the waterside (WS) toe with butterfly valve. (8-inch pipe and conduit authorized under Permit No. 17191, 2000 - Lake County Land and Cattle, LLC). FS Date: 10/23/2019 1:20:00 PM

Pump and pipe on WS berm.

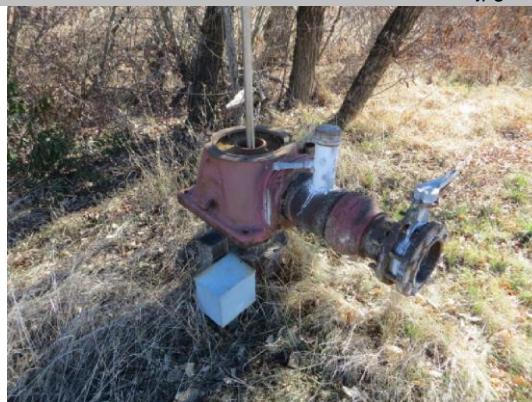
Photo 2 of 3 : UCIP\_FA\_2019\_55753\_51273.jpg

Pump and pipe on WS berm with butterfly valve.

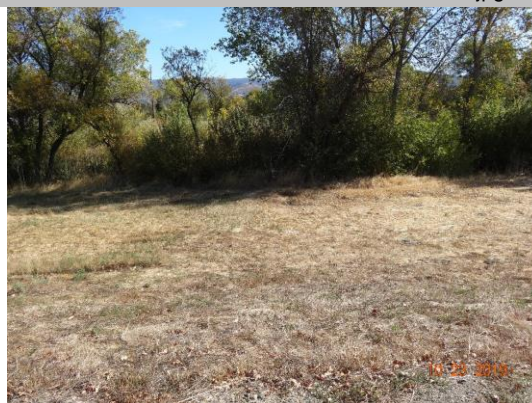
Photo 3 of 3 : UCIP\_FA\_2019\_55753\_82693.jpg

Comment Code						
Inspector Comment						
DS_ID:21245 FS_ID:55753 EP_NO: 17191 Repair Type: Non-Urgent Crossing Status: Found UCIP Comments: 10/23/2019 Record has been updated from No Action Needed to Non-Urgent, pipe appears to be abandoned; need to audit record to confirm owner. The UCIP inspection was completed with DWR Inspector, L. Dial, and LMA representative, S. Webb. (O. Magana - DWR UCIP) FIELD_STRUCT_DESC: 1 of 2: 8-inch coated steel irrigation pipe through the levee, 2 feet below the crown. Well and electric pump at the waterside (WS) toe with butterfly valve. (8-inch pipe and conduit authorized under Permit No. 17191, 2000 - Lake County Land and Cattle, LLC). FS Date: 10/23/2019 1:20:00 PM

WS view: overview of WS.

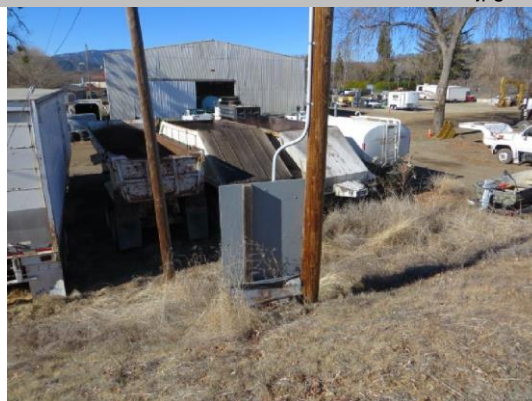
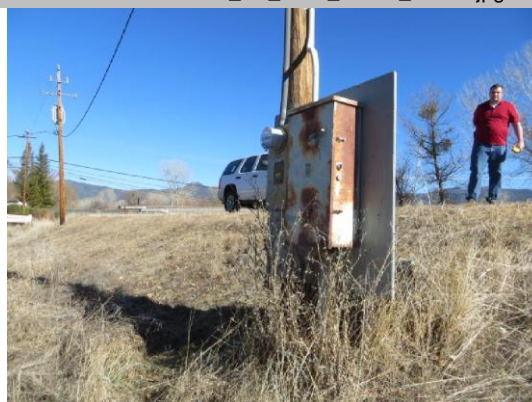
LM Start	<b>2.00</b>	Rating **	M	Issue No.	<b>54 (cont)</b>
LM End	<b>2.00</b>	Issue Type +	En	Location *

Comment Code						
Inspector Comment						
DS_ID:21250 FS_ID:55755 EP_NO: 17191 Repair Type: Non-Urgent Crossing Status: Found UCIP Comments: 10/23/2019 Record remains Non-Urgent, pipe appears to be abandoned; need to audit record to confirm owner. The UCIP inspection was completed with DWR Inspector, L. Dial, and LMA representative, S. Webb. (O. Magana - DWR UCIP)01/22/2014 Appears abandoned, if so it should be done so properly. (W. Wylie - DWR UCIP) FIELD_STRUCT_DESC: 2 of 2: 2-inch polyvinyl chloride electrical conduit through the levee, 2 feet below the crown. Well and electric pump at the waterside (WS) toe. Pole and meter. (8-inch pipe and conduit authorized under Permit No. 17191, 2000 - Lake County Land and Cattle, LLC). FS Date: 10/23/2019 1:21:00 PM

Meter and control on LS slope next to pole.

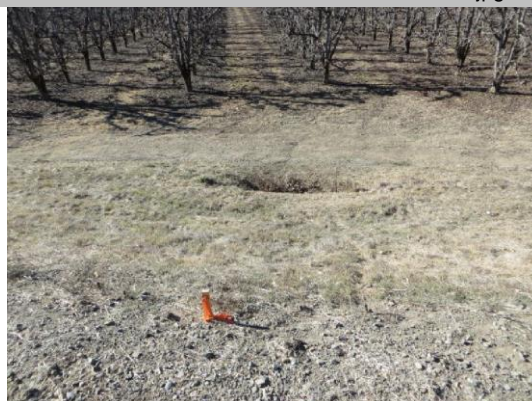
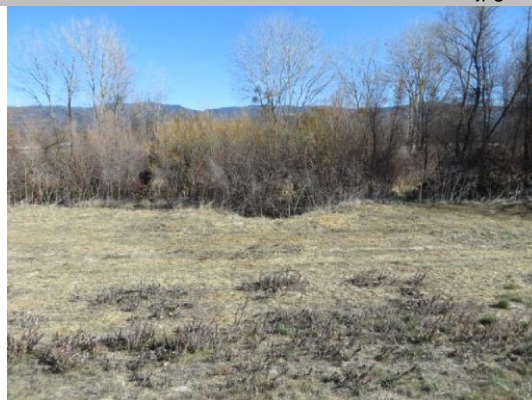
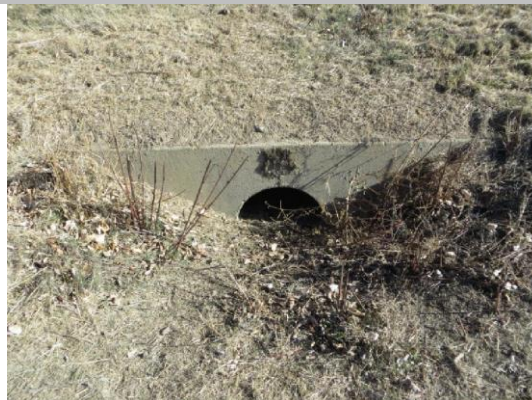
LM Start	<b>2.84</b>	Rating **	M	Issue No.	<b>55 (cont)</b>
LM End	<b>2.84</b>	Issue Type +	Ma	Location *

Comment Code						
Inspector Comment						
DS_ID:21215 FS_ID:55756 EP_NO: 11481 Repair Type: Non-Urgent Crossing Status: Found UCIP Comments: 10/23/2019 Record remains Non-Urgent; need to audit record to confirm owner. Crossing has been internally inspected under the DWR DMP Phase 1 project. Inspection report is still not available. The UCIP inspection was completed with DWR Inspector, L. Dial, and LMA representative, S. Webb. (O. Magana - DWR UCIP)01/22/2014 Soil partially blocking inlet and outlet. (W. Wylie - DWR UCIP) FIELD_STRUCT_DESC: 24-inch corrugated metal drainage pipe through the levee, 12 feet below the crown. Flap gate on the waterside (WS) end. Concrete headwalls on both ends. (24-inch pipe [HLM 2.93] retained under Automatic Board Order (ABO) issued as Permit no. 11481, 1975 - Dennis P. McCarthy). [Additional Reference(s): DWR Levee Log, 2005. USACE Sacramento O&M Manual 506.2, August 1961, (HLM 2.93), Station M173+00, 24-inch pipe, dwg no. CC-4-4-29, Index Sheet 4: page 4, 38 of 64]. FS Date: 10/23/2019 1:22:00 PM

Concrete headwall and pipe visible at LS toe.

Concrete headwall and flapgate visible at WS berm.

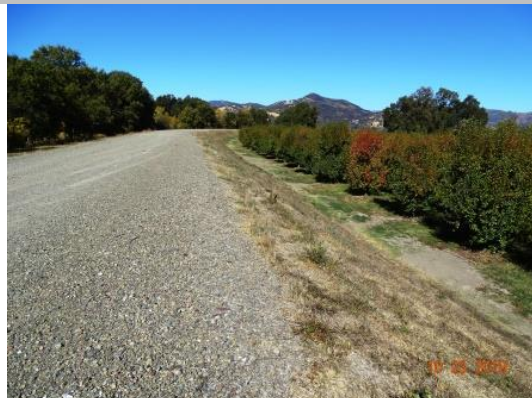
Photo 1 of 1 : FA\_2019\_NA0009\_5\_19\_20191025\_00042.jpg

LM Start	0.23	Rating **	A	Issue No.	19
LM End	0.92	Issue Type +	Ma	Location *	LS
Category	Earthen Levee			GPS Latitude/Longitude	
				Start	End
Item	Vegetation			39.150733 °	39.159723 °
				-122.916267 °	-122.920993 °
DWR ID	DWR_NA0009_03_f_2019_19				
Comment Code					
V1 : Control annual grass and weeds on the levee slopes and easements.					
Inspector Comment

View of well-maintained landside vegetation. Fall 2019

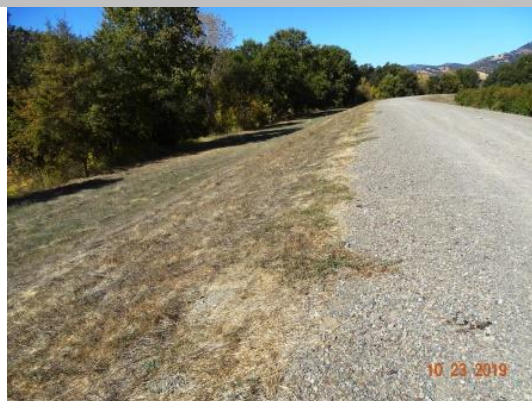
Photo 1 of 1 : FA\_2019\_NA0009\_5\_20\_20191025\_00043.jpg

LM Start	0.23	Rating **	A	Issue No.	20
LM End	0.93	Issue Type +	Ma	Location *	WS
Category	Earthen Levee			GPS Latitude/Longitude	
				Start	End
Item	Vegetation			39.150733 °	39.159762 °
				-122.916267 °	-122.921122 °
DWR ID	DWR_NA0009_03_f_2019_20				
Comment Code					
V1 : Control annual grass and weeds on the levee slopes and easements.					
Inspector Comment

View of well-maintained waterside vegetation. Fall 2019

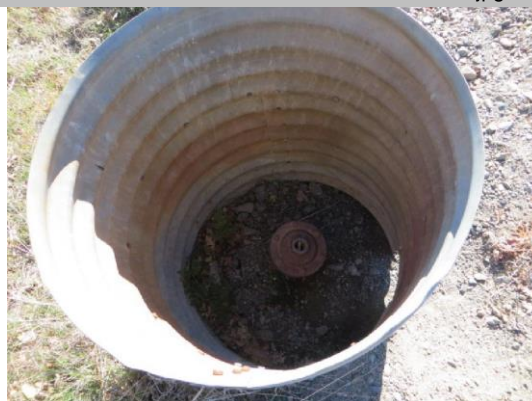
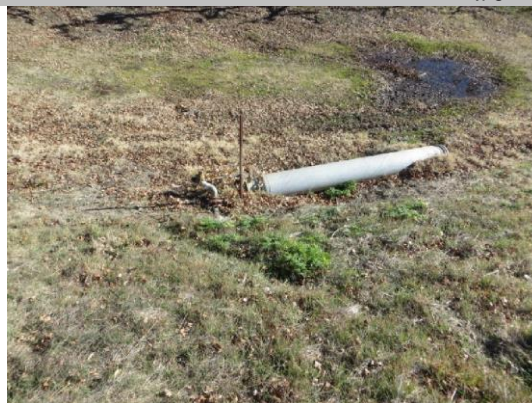
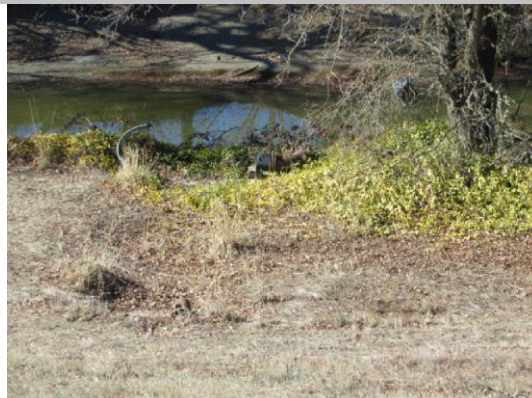
LM Start	<b>0.40</b>	Rating **	M	Issue No.	<b>27 (cont)</b>
LM End	<b>0.40</b>	Issue Type +	En	Location *

Comment Code						
Inspector Comment						
DS_ID:21216 FS_ID:55768 EP_NO: 11492 Repair Type: Non-Urgent Crossing Status: Found UCIP Comments: 10/24/2019 Record has been updated from No Action Needed to Non-Urgent; need to audit record to confirm owner. (O. Magana - DWR UCIP) FIELD_STRUCT_DESC: 6-inch steel irrigation pipe through the levee, 2 feet below the crown. Siphon breaker in 24-inch corrugated metal riser unit on the landside (LS) slope. Steel cap on the waterside (WS) berm. 1.5-inch polyvinyl chloride electrical conduit at same location with electrical panel on the LS toe just off to the north. (Pipe retained under Automatic Board Order (ABO) issued as Permit No. 11492, 1975 - Dennis P. McCarthy). [Additional Reference(s): DWR Levee Log, 2005. USACE Sacramento O&M Manual 506.2, August 1961, (HLM 0.41), Station S26+50, 6-inch pipe, dwg no. CC-4-4-29, Index Sheet 4: page 4, 38 of 64]. FS Date: 10/24/2019 12:25:00 PM

Siphon breaker in 24-inch CMP riser on SL slope.

Filter, pipe, and valve visible on LS toe.

Pump mount, pipe, and electrical conduit visible on WS berm.

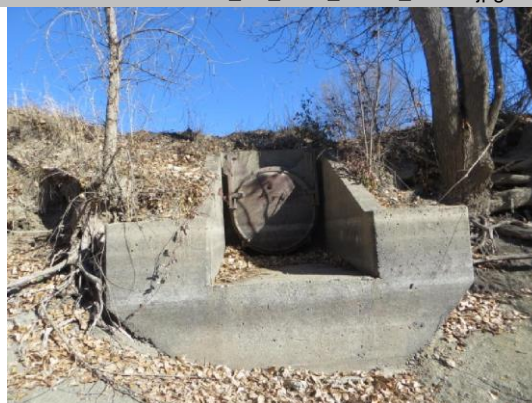
Photo 3 of 3 : UCIP\_FA\_2019\_55769\_51540.jpg

DS\_ID:21217  
FS\_ID:55769  
EP\_NO: 11492  
Repair Type: Non-Urgent  
Crossing Status: Found  
UCIP Comments: 10/24/2019 Record remains Non-Urgent; need to audit record to confirm owner. Crossing has been internally inspected under the DWR DMP Phase 1 project. Inspection report is still not available. (O. Magana - DWR UCIP)01/22/2014 Vegetation at inlet and wooden box failing at LS toe. (W. Wylie - DWR UCIP)  
FIELD\_STRUCT\_DESC: 42-inch corrugated metal drainage pipe through the levee, 12 feet below the crown. Flap gate on the waterside (WS) end. Concrete headwalls on both ends with a wooden retaining wall drop inlet at the landside (LS) toe. (42-inch pipe [HLM 0.55] retained under Automatic Board Order (ABO) issued as Permit No. 11492, 1975 - Dennis P. McCarthy). [Additional Reference(s): DWR Levee Log, 2005. USACE Sacramento O&M Manual 506.2, August 1961, (HLM 0.55), Station S32+50, 42-inch pipe, dwg no. CC-4-4-29, Index Sheet 4: page 4, 38 of 64].

Concrete headwall and flapgate visible at WS berm.

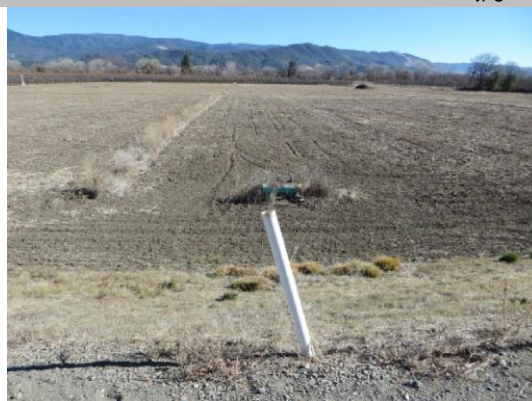
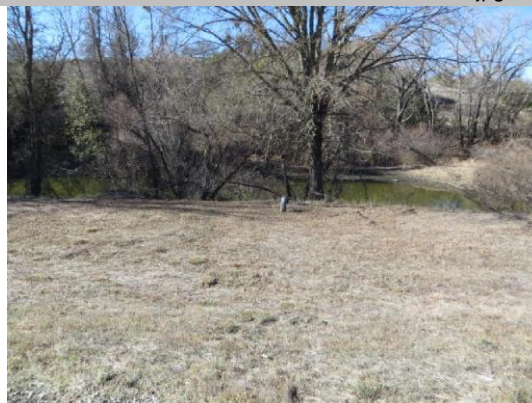
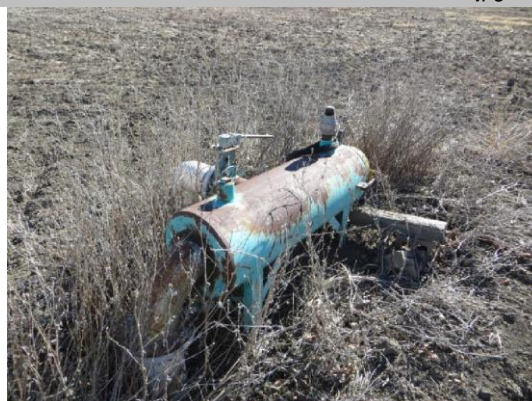
LM Start	<b>0.64</b>	Rating **	M	Issue No.	<b>30 (cont)</b>
LM End	<b>0.64</b>	Issue Type +	En	Location *

Comment Code						
Inspector Comment						
DS_ID:21244 FS_ID:55770 EP_NO: 17190 Repair Type: Non-Urgent Crossing Status: Found UCIP Comments: 10/24/2019 Record has been updated from No Action Needed to Non-Urgent, pipe has been abandoned; need to audit record to confirm owner. Pipe owner has sealed WS pipe. (O. Magana - DWR UCIP)01/22/2014 Appears abandoned and if so should be done so properly. Steel blankoff plate installed on WS berm. (W. Wylie - DWR UCIP) FIELD_STRUCT_DESC: 8-inch steel irrigation pipe through the levee, 2.7 feet below the crown. Siphon breaker on apex of pipe at the landside (LS) shoulder. Exposed filter off LS toe with vent and shutoff valve. Seasonal pump on the waterside (WS) slope. (8-inch pipe authorized under Permit No. 17190, 2000 - Lake County Land and Cattle, LLC). FS Date: 10/24/2019 12:26:00 PM

Vent on LS shoulder with filter visible off LS toe.

Pipe and concrete pad visible off WS toe on WS berm.

Filter, shutoff valve, and vent visible off LS toe.

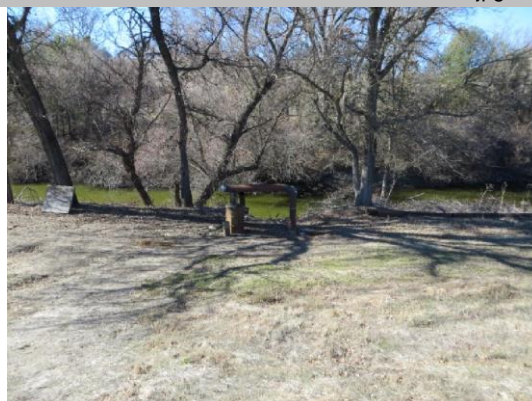
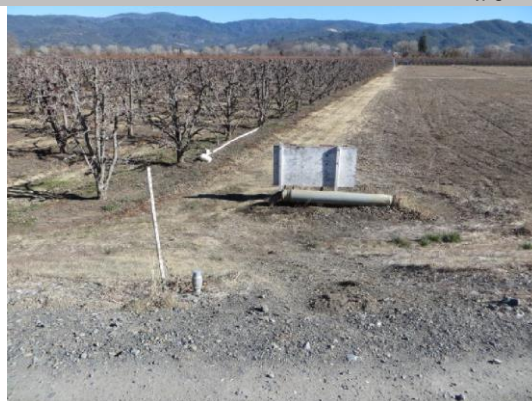
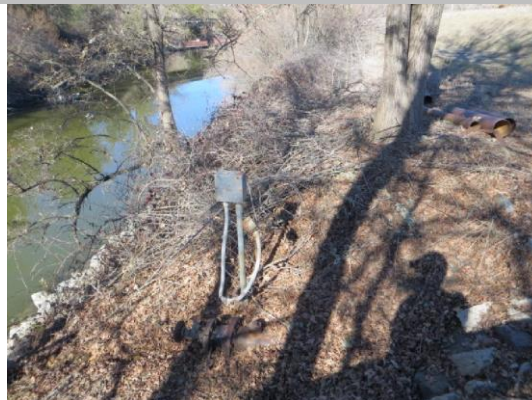
LM Start	<b>0.70</b>	Rating **	U	Issue No.	<b>31 (cont)</b>
LM End	<b>0.70</b>	Issue Type +	En	Location *

Comment Code					
Inspector Comment					
DS_ID:21218 FS_ID:55767 EP_NO: 9797 Repair Type: Urgent Crossing Status: Found UCIP Comments: 10/24/2019 Record has been updated from No Action Needed to Urgent, siphon breaker is leaking and causing erosion to the LS slope. Need to contact owner to address leaky siphon breaker. Modifications have been made to the WS pipe section and appurtenances. LMA representative, S. Webb, was notified of leaky siphon breaker. (O. Magana - DWR UCIP) FIELD_STRUCT_DESC: 8-inch steel irrigation pipe through the levee, 2.7 feet below the crown. Steel cutoff wall around pipe at center of levee. Siphon breaker on apex of pipe at the landside (LS) shoulder. Exposed filter on LS slope. Portable pump on the waterside (WS) slope. Electrical panel next to filter at the LS toe. (8-inch pipe authorized under Permit No. 9797, 1974 - Dennis P. McCarthy). [Additional Reference(s): DWR Levee Log, 2005]. FS Date: 10/24/2019 12:26:00 PM

Pipe and pump pad visible off WS toe.

Siphon Breaker on LS shoulder with filter and electrical panel visible at LS toe.

Electrical conduit visible on WS berm.

Comment Code						
Inspector Comment						
DS_ID:21218 FS_ID:55767 EP_NO: 9797 Repair Type: Urgent Crossing Status: Found UCIP Comments: 10/24/2019 Record has been updated from No Action Needed to Urgent, siphon breaker is leaking and causing erosion to the LS slope. Need to contact owner to address leaky siphon breaker. Modifications have been made to the WS pipe section and appurtenances. LMA representative, S. Webb, was notified of leaky siphon breaker. (O. Magana - DWR UCIP) FIELD_STRUCT_DESC: 8-inch steel irrigation pipe through the levee, 2.7 feet below the crown. Steel cutoff wall around pipe at center of levee. Siphon breaker on apex of pipe at the landside (LS) shoulder. Exposed filter on LS slope. Portable pump on the waterside (WS) slope. Electrical panel next to filter at the LS toe. (8-inch pipe authorized under Permit No. 9797, 1974 - Dennis P. McCarthy). [Additional Reference(s): DWR Levee Log, 2005]. FS Date: 10/24/2019 12:26:00 PM

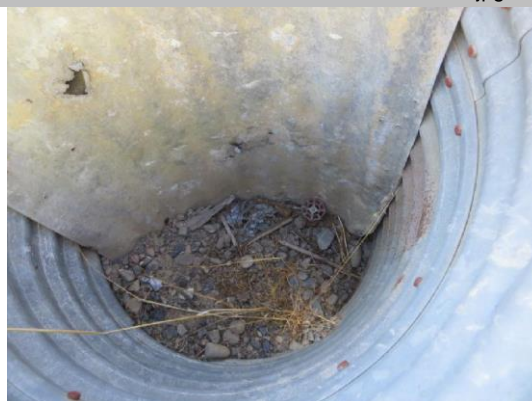
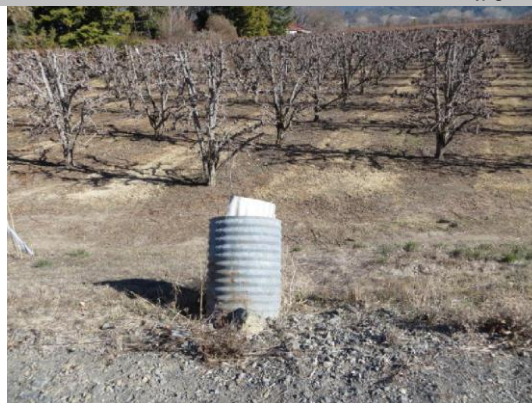
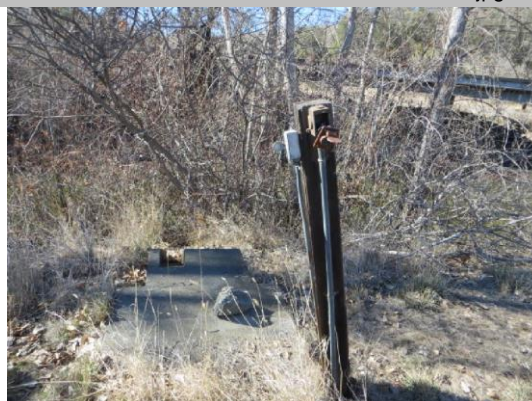
LM Start	<b>0.75</b>	Rating **	M	Issue No.	<b>32 (cont)</b>
LM End	<b>0.75</b>	Issue Type +	En	Location *

Comment Code						
Inspector Comment						
DS_ID:21219 FS_ID:55775 EP_NO: 11492 Repair Type: Non-Urgent Crossing Status: Indicator Found UCIP Comments: 10/24/2019 Record remains Non-Urgent, pipe appears to be abandoned; need to audit record to confirm owner. Owner will need to coordinate with the CVFPB to remove or abandon crossing according to Title 23 requirements. (O. Magana - DWR UCIP)01/22/2014 Appears abandoned and if so should be done so properly. (W. Wylie - DWR UCIP) FIELD_STRUCT_DESC: 4-inch steel irrigation pipe through the levee, 2.5 feet below the crown. Siphon breaker in 24-inch corrugated metal riser unit on the landside (LS) shoulder. Pump on concrete platform on the waterside (WS). Hose chute and concrete stairway on the WS slope. (Pipe retained under Automatic Board Order (ABO) issued as Permit No. 11492, 1975 - Dennis P. McCarthy). [Additional Reference(s): DWR Levee Log, 2005]. FS Date: 10/24/2019 12:27:00 PM

Valve visible at bottom of CMP riser on LS shoulder.

Siphon at LS shoulder inside 24-inch CMP riser.

Concrete pump pad and electrical works visible on WS berm.

Comment Code						
Inspector Comment						
DS_ID:21219 FS_ID:55775 EP_NO: 11492 Repair Type: Non-Urgent Crossing Status: Indicator Found UCIP Comments: 10/24/2019 Record remains Non-Urgent, pipe appears to be abandoned; need to audit record to confirm owner. Owner will need to coordinate with the CVFPB to remove or abandon crossing according to Title 23 requirements. (O. Magana - DWR UCIP)01/22/2014 Appears abandoned and if so should be done so properly. (W. Wylie - DWR UCIP) FIELD_STRUCT_DESC: 4-inch steel irrigation pipe through the levee, 2.5 feet below the crown. Siphon breaker in 24-inch corrugated metal riser unit on the landside (LS) shoulder. Pump on concrete platform on the waterside (WS). Hose chute and concrete stairway on the WS slope. (Pipe retained under Automatic Board Order (ABO) issued as Permit No. 11492, 1975 - Dennis P. McCarthy). [Additional Reference(s): DWR Levee Log, 2005]. FS Date: 10/24/2019 12:27:00 PM

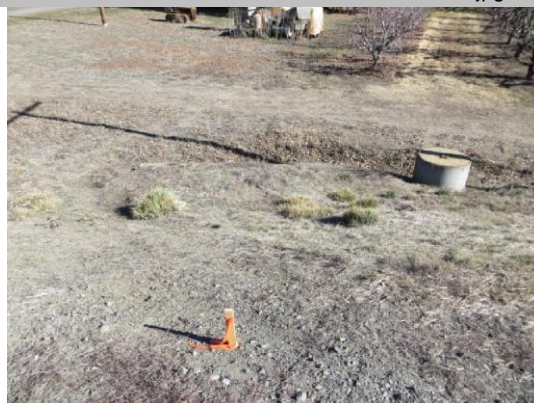
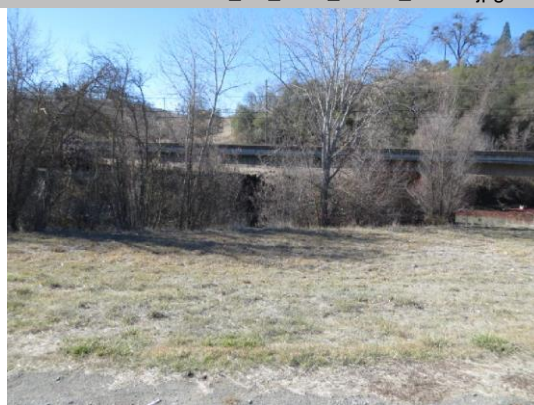
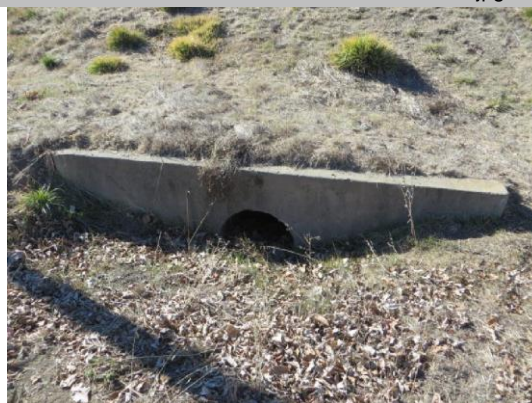
LM Start	<b>0.77</b>	Rating **	M	Issue No.	<b>33 (cont)</b>
LM End	<b>0.77</b>	Issue Type +	Ma	Location *

Comment Code						
Inspector Comment						
DS_ID:21220 FS_ID:55778 EP_NO: 11492 Repair Type: Non-Urgent Crossing Status: Found UCIP Comments: 10/24/2019 Record remains Non-Urgent; need to audit record to confirm owner. Crossing has been internally inspected under the DWR DMP Phase 1 project. Inspection report is still not available. Also need to determine the purpose of concrete riser located on the LS toe just d/s of the 24-inch pipe. Unable to determine purpose for deep riser located on the LS toe or if it crosses levee. Recommend further exploration of this riser and determine who owns it. (O. Magana DWR UCIP)01/22/2014 Some sediment buildup at inlet. (W. Wylie - DWR UCIP) FIELD_STRUCT_DESC: 24-inch corrugated metal drainage pipe through the levee, 10 feet below the crown. Flap gate on the waterside (WS) end. Concrete headwalls on both ends. Concrete spillway on the WS slope to bottom of channel. (24-inch pipe [HLM 0.79] retained under Automatic Board Order (ABO) issued as Permit No. 11492, 1975 - Dennis P. McCarthy). [Additional Reference(s): DWR Levee Log, 2005. USACE Sacramento O&M Manual 506.2, August 1961, (HLM 0.79), Station S46+40.56, 24-inch pipe, dwg no. CC-4-4-29, Index Sheet 4: page 4, 38 of 64]. FS Date: 10/24/2019 12:27:00 PM

Concrete headwall visible next to concrete standpipe on LS toe.

Concrete outfall visible off WS berm.

Concrete headwall visible at LS toe.

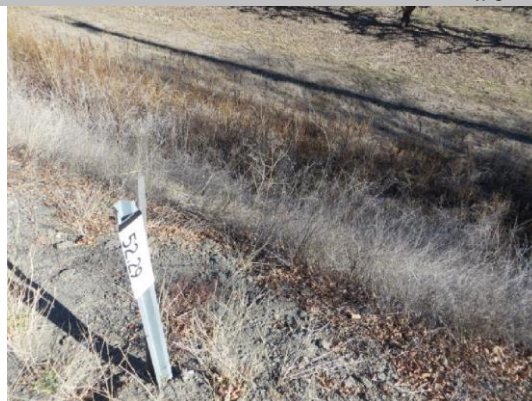
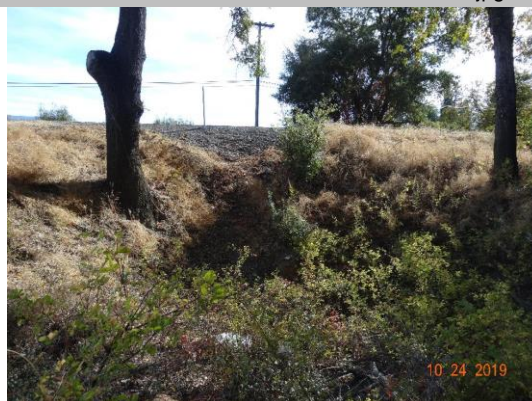
LM Start	<b>0.90</b>	Rating **	M	Issue No.	<b>34 (cont)</b>
LM End	<b>0.90</b>	Issue Type +	Ma	Location *

Roadway marker 52.29 on LS and WS shoulder mark pipe location on crown.

Comment Code						
Inspector Comment						
DS_ID:21247 FS_ID:55781 EP_NO: N/A Repair Type: Non-Urgent Crossing Status: Found UCIP Comments: 10/24/2019 Record has been updated from No Action Needed to Non-Urgent, need to audit record to determine current owner. No other issues were recorded at this location. Pipe crossing appears to have been abandoned back in 1961. USACE O&M manual and drawings indicate pipe has been plugged with concrete. Coordinates has been updated from 39.159628, 122.920853 to 39.159278, -122.920783 to reflect actual location of pipe crossing. Pipe crosses State Route 29. (O. Magana - DWR UCIP) FIELD_STRUCT_DESC: *ABANDONED* 36-inch corrugated metal drainage pipe through the levee, 10 feet below the crown. Plugged with concrete. [Additional Reference(s): USACE Sacramento O&M Manual 506.2, August 1961, (HLM 0.90), Station S50+85, 36-inch pipe plugged with concrete, dwg no. CC-4-4-29, Index Sheet 4: page 4, 38 of 64]. FS Date: 10/24/2019 12:28:00 PM

WS view: overview of WS looking towards levee/State Route 29.

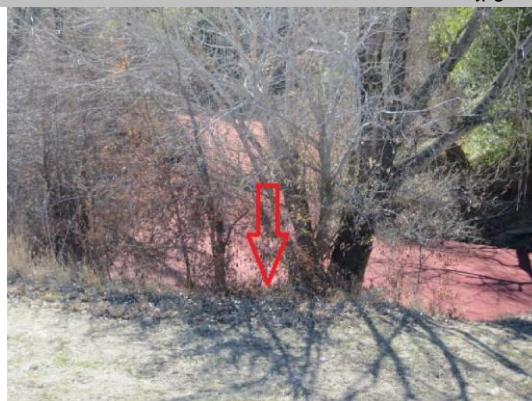
Photo 1 of 3 : UCIP\_FA\_2019\_55782\_51599.jpg

Comment Code					
Inspector Comment					
DS_ID:21221 FS_ID:55782 EP_NO: 11488 Repair Type: Non-Urgent Crossing Status: Found UCIP Comments: 10/24/2019 Record remains Non-Urgent due to 2-foot scour under headwall noted in 2014; need to audit record to confirm owner. Crossing has been internally inspected under the DWR DMP Phase 1 project. Inspection report is still not available. (O. Magana - DWR UCIP)01/22/2014 Concrete headwall on WS berm is being undermined. 2-foot of scour under headwall. (W. Wylie - DWR UCIP) FIELD_STRUCT_DESC: 42-inch corrugated metal drainage pipe through the levee, 16.5 feet below the crown. Flap gate on the waterside (WS) end. Concrete headwalls on both ends. (42-inch pipe [HLM 0.94] retained under Automatic Board Order (ABO) issued as Permit No. 11488, 1975 - Robert F. and Mary E. Wheeler). [Additional Reference(s): DWR Levee Log, 2005. USACE Sacramento O&M Manual 506.2, August 1961, (HLM 0.94), Station S53+84, 42-inch pipe, dwg no. CC-4-4-29, Index Sheet 4: page 4, 38 of 64]. FS Date: 10/24/2019 12:28:00 PM

Flapgate and headwall off WS toe.

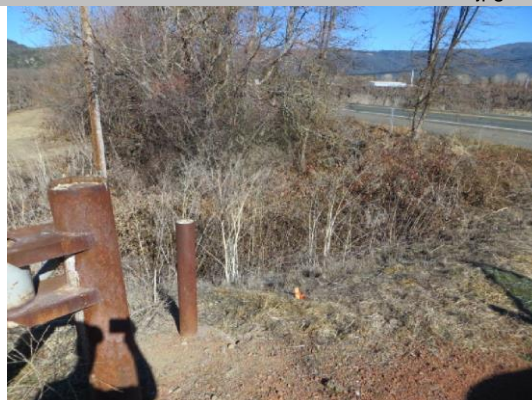
Photo 2 of 3 : UCIP\_FA\_2019\_55782\_51598.jpg

Concrete headwall on LS toe.

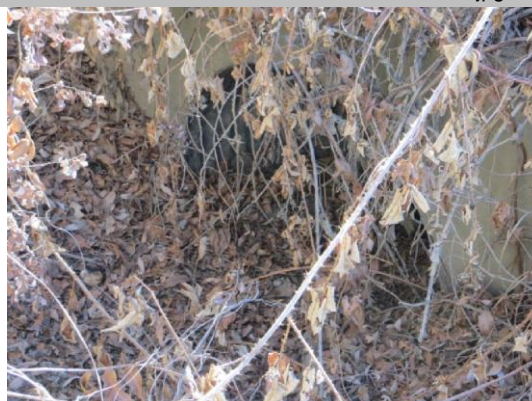
Photo 3 of 3 : UCIP\_FA\_2019\_55782\_51597.jpg

Comment Code						
Inspector Comment						
DS_ID:21221 FS_ID:55782 EP_NO: 11488 Repair Type: Non-Urgent Crossing Status: Found UCIP Comments: 10/24/2019 Record remains Non-Urgent due to 2-foot scour under headwall noted in 2014; need to audit record to confirm owner. Crossing has been internally inspected under the DWR DMP Phase 1 project. Inspection report is still not available. (O. Magana - DWR UCIP)01/22/2014 Concrete headwall on WS berm is being undermined. 2-foot of scour under headwall. (W. Wylie - DWR UCIP) FIELD_STRUCT_DESC: 42-inch corrugated metal drainage pipe through the levee, 16.5 feet below the crown. Flap gate on the waterside (WS) end. Concrete headwalls on both ends. (42-inch pipe [HLM 0.94] retained under Automatic Board Order (ABO) issued as Permit No. 11488, 1975 - Robert F. and Mary E. Wheeler). [Additional Reference(s): DWR Levee Log, 2005. USACE Sacramento O&M Manual 506.2, August 1961, (HLM 0.94), Station S53+84, 42-inch pipe, dwg no. CC-4-4-29, Index Sheet 4: page 4, 38 of 64]. FS Date: 10/24/2019 12:28:00 PM

Concrete headwall on LS toe.

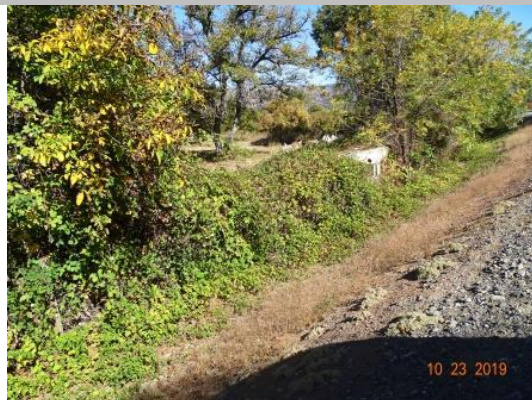
Photo 1 of 2 : FA\_2019\_NA0009\_5\_12\_20191025\_00044.jpg

LM Start	0.97	Rating **	M	Issue No.	12
LM End	1.07	Issue Type +	Ma	Location *	LS
Category	Earthen Levee			GPS Latitude/Longitude	
				Start	End
Item	Vegetation			39.160042 °	39.159783 °
				-122.921800 °	-122.923517 °
DWR ID	DWR_NA0009_03_s_2016_12				
Comment Code					
V2 : Remove the wild growth other than native grasses from the levee slopes.					
Inspector Comment					
The LMA removed most of the growth except for the remainder on the fence.

View of vines covering the fence along the landside toe. Fall 2019

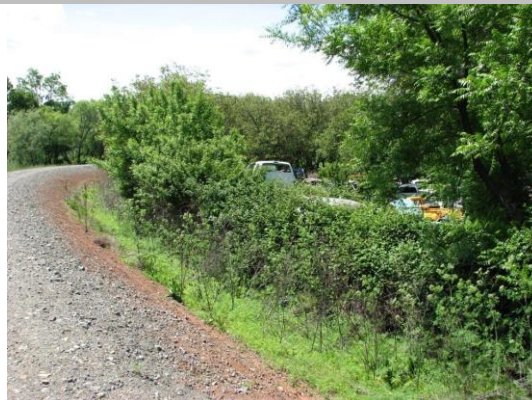
Photo 2 of 2 : FA\_2019\_NA0009\_5\_12\_20190904\_00002.jpg

LM Start	0.97	Rating **	M	Issue No.	12 (cont)	
LM End	1.07	Issue Type +	Ma	Location *	LS	
Category	Earthen Levee			GPS Latitude/Longitude		
				Start		End
Item	Vegetation			39.160042°	39.159783°	
				-122.921800°	-122.923517°	
DWR ID	DWR_NA0009_03_s_2016_12					
Comment Code						
V2 : Remove the wild growth other than native grasses from the levee slopes.						
Inspector Comment						
The LMA removed most of the growth except for the remainder on the fence.

5/2/2016: Dense bushes and vines covering fence along vehicle junk yard.

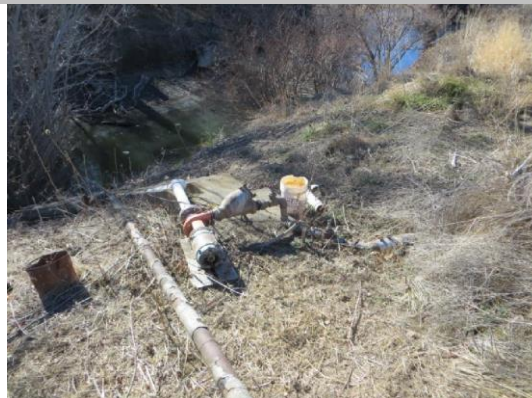
Photo 1 of 3 : UCIP\_FA\_2019\_55783\_51622.jpg

Comment Code						
Inspector Comment						
DS_ID:21248 FS_ID:55783 EP_NO: 11488 Repair Type: Non-Urgent Crossing Status: Indicator Found UCIP Comments: 10/24/2019 Record remains Non-Urgent; need to audit record to confirm owner. Pipe and appurtenances appear to have been modified. Need to contact owner to obtain permit authorizing modifications to crossing. (O. Magana - DWR UCIP)01/22/2014 Siphon breaker standpipe knocked over and covered with dirt. Pipe and appurtenances appear to be in disrepair. Gate valves next to tank broken. (W. Wylie - DWR UCIP) FIELD_STRUCT_DESC: 6-inch steel irrigation pipe through the levee, 2.5 feet below the crown. Siphon breaker in 24-inch corrugated metal riser unit on the landside (LS) shoulder. Screw gate on the waterside (WS) slope next to pump and 300-gallon tank. (Pipe retained under Automatic Board Order (ABO) issued as Permit No. 11488, 1975 - Robert F. and Mary E. Wheeler). [Additional Reference(s): USACE Sacramento O&M Manual 506.2, August 1961, (HLM 1.02)]. FS Date: 10/24/2019 12:28:00 PM

Pump at concrete pad on WS berm.

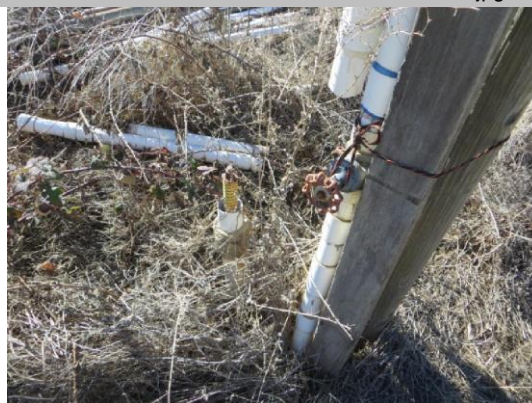
Photo 3 of 3 : UCIP\_FA\_2019\_55783\_51620.jpg

Comment Code						
Inspector Comment						
DS_ID:21248 FS_ID:55783 EP_NO: 11488 Repair Type: Non-Urgent Crossing Status: Indicator Found UCIP Comments: 10/24/2019 Record remains Non-Urgent; need to audit record to confirm owner. Pipe and appurtenances appear to have been modified. Need to contact owner to obtain permit authorizing modifications to crossing. (O. Magana - DWR UCIP)01/22/2014 Siphon breaker standpipe knocked over and covered with dirt. Pipe and appurtenances appear to be in disrepair. Gate valves next to tank broken. (W. Wylie - DWR UCIP) FIELD_STRUCT_DESC: 6-inch steel irrigation pipe through the levee, 2.5 feet below the crown. Siphon breaker in 24-inch corrugated metal riser unit on the landside (LS) shoulder. Screw gate on the waterside (WS) slope next to pump and 300-gallon tank. (Pipe retained under Automatic Board Order (ABO) issued as Permit No. 11488, 1975 - Robert F. and Mary E. Wheeler). [Additional Reference(s): USACE Sacramento O&M Manual 506.2, August 1961, (HLM 1.02)]. FS Date: 10/24/2019 12:28:00 PM

filler valves on LS toe.

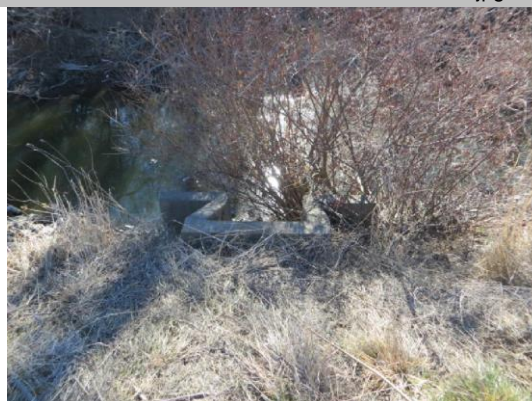
Photo 1 of 3 : UCIP\_FA\_2019\_55784\_51642.jpg

Comment Code					
Inspector Comment					
DS_ID:21222 FS_ID:55784 EP_NO: 11488 Repair Type: Non-Urgent Crossing Status: Found UCIP Comments: 10/24/2019 Record remains Non-Urgent due to scour developing behind d/s wingwall; need to audit record to confirm owner. Crossing has been internally inspected under the DWR DMP Phase 1 project. Inspection report is still not available. (O. Magana - DWR UCIP)01/22/2014 Some vegetation buildup at inlet and outlet. (W. Wylie - DWR UCIP) FIELD_STRUCT_DESC: 24-inch corrugated metal drainage pipe through the levee, 14 feet below the crown. Flap gate on the waterside (WS) end. Concrete headwalls on both ends. (24-inch pipe [HLM 1.01] retained under Automatic Board Order (ABO) issued as Permit No. 11488, 1975 - Robert F. and Mary E. Wheeler). [Additional Reference(s): DWR Levee Log, 2005. USACE Sacramento O&M Manual 506.2, August 1961, (HLM 1.01), Station S57+06, 24-inch pipe, dwg no. CC-4-4-29, Index Sheet 4: page 4, 38 of 64]. FS Date: 10/24/2019 12:29:00 PM

Concrete Headwall on WS berm.

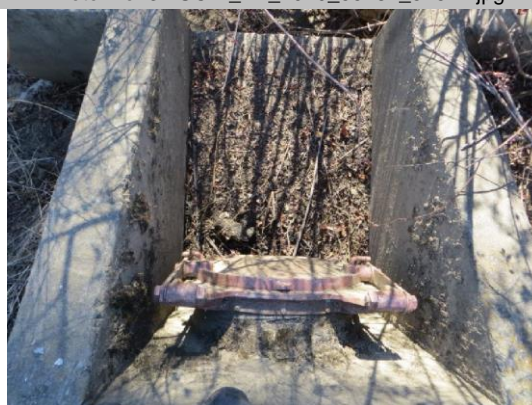
Photo 2 of 3 : UCIP\_FA\_2019\_55784\_51641.jpg

Headwall and flapgate on WS berm.

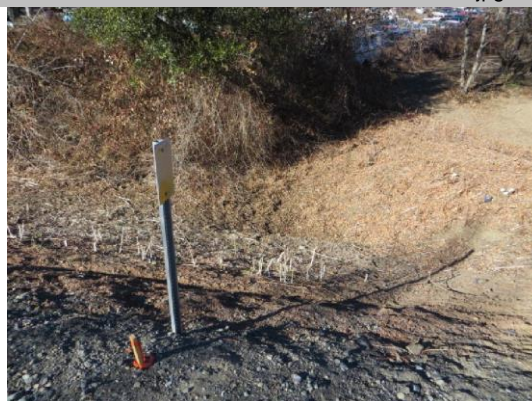
Photo 1 of 3 : UCIP\_FA\_2019\_55785\_51646.jpg

Comment Code						
Inspector Comment						
DS_ID:21223 FS_ID:55785 EP_NO: 11489 Repair Type: Non-Urgent Crossing Status: Found UCIP Comments: 10/24/2019 Record remains Non-Urgent; need to audit record to confirm owner. Crossing has been internally inspected under the DWR DMP Phase 1 project. Inspection report is still not available. (O. Magana - DWR UCIP)01/22/2014 Some sedimentation buildup at inlet and through pipe. (W. Wylie - DWR UCIP) FIELD_STRUCT_DESC: 24-inch corrugated metal drainage pipe through the levee, 12.5 feet below the crown. Flap gate on the waterside (WS) end. Concrete headwalls on both ends. (24-inch pipe [HLM 1.09] retained under Automatic Board Order (ABO) issued as Permit No. 11489, 1975 - Bank of Upper Lake). [Additional Reference(s): DWR Levee Log, 2005. USACE Sacramento O&M Manual 506.2, August 1961, (HLM 1.09), Station S60+40, 24-inch pipe, dwg no. CC-4-4-29, Index Sheet 4: page 4, 38 of 64]. FS Date: 10/24/2019 12:29:00 PM

Flasher on crown marks pipe location.

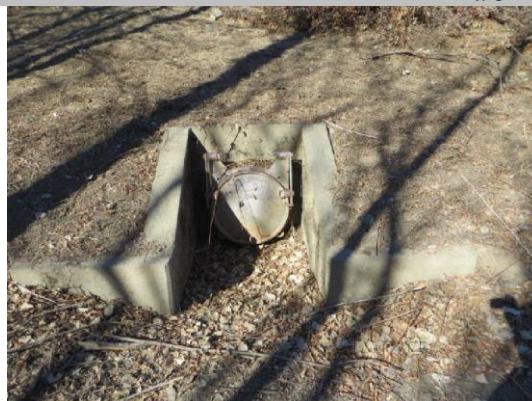
Photo 2 of 3 : UCIP\_FA\_2019\_55785\_51645.jpg

Flapgate and headwall visible on WS toe.

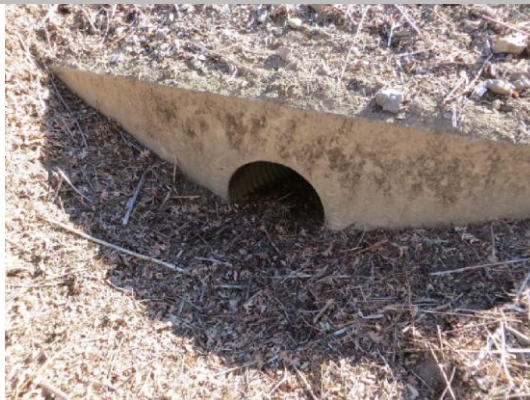
Photo 3 of 3 : UCIP\_FA\_2019\_55785\_51644.jpg

Comment Code						
Inspector Comment						
DS_ID:21223 FS_ID:55785 EP_NO: 11489 Repair Type: Non-Urgent Crossing Status: Found UCIP Comments: 10/24/2019 Record remains Non-Urgent; need to audit record to confirm owner. Crossing has been internally inspected under the DWR DMP Phase 1 project. Inspection report is still not available. (O. Magana - DWR UCIP)01/22/2014 Some sedimentation buildup at inlet and through pipe. (W. Wylie - DWR UCIP) FIELD_STRUCT_DESC: 24-inch corrugated metal drainage pipe through the levee, 12.5 feet below the crown. Flap gate on the waterside (WS) end. Concrete headwalls on both ends. (24-inch pipe [HLM 1.09] retained under Automatic Board Order (ABO) issued as Permit No. 11489, 1975 - Bank of Upper Lake). [Additional Reference(s): DWR Levee Log, 2005. USACE Sacramento O&M Manual 506.2, August 1961, (HLM 1.09), Station S60+40, 24-inch pipe, dwg no. CC-4-4-29, Index Sheet 4: page 4, 38 of 64]. FS Date: 10/24/2019 12:29:00 PM

Concrete headwall on LS toe.

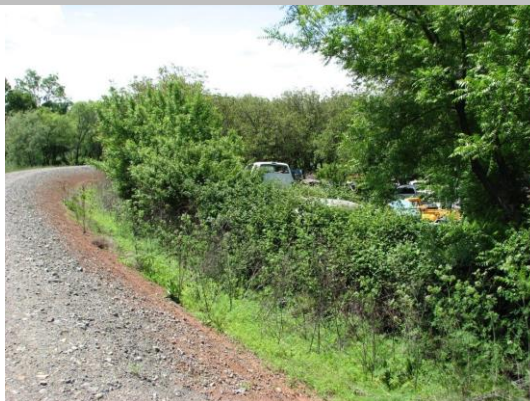
Photo 1 of 1 : FA\_2019\_NA0009\_5\_13\_20190904\_00003.jpg

LM Start	1.07	Rating **	U	Issue No.	13
LM End	1.13	Issue Type +	En	Location *	LS
Category	Earthen Levee			GPS Latitude/Longitude	
				Start	End
Item	Encroachments			39.159789 °	39.159613 °
				-122.923515 °	-122.924643 °
DWR ID	DWR_NA0009_03_s_2016_13				
Comment Code					
AV : Abandoned vehicles					
Inspector Comment					
Junk yard full of abandoned vehicles, some stacked at levee toe obstructing visibility and access to levee toe.

5/2/2016: Vehicle junk yard behind fence covered in dense growth of bushes and vines.

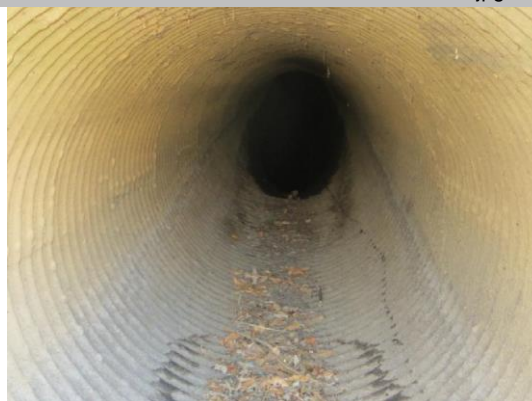
Photo 2 of 3 : UCIP\_FA\_2019\_55786\_51661.jpg

Comment Code						
Inspector Comment						
DS_ID:21224 FS_ID:55786 EP_NO: 11489 Repair Type: Non-Urgent Crossing Status: Found UCIP Comments: 10/24/2019 Record has been updated from No Action needed to Non-Urgent; need to audit record to confirm owner. Crossing has been internally inspected under the DWR DMP Phase 1 project. Inspection report is still not available. (O. Magana - DWR UCIP) FIELD_STRUCT_DESC: 1 of 4: 36-inch corrugated metal drainage pipe through the levee, 15.2 feet below the crown. Flap gate on the waterside (WS) end. Concrete headwalls on both ends. (four 36-inch pipes [HLM 1.25] retained under Automatic Board Order (ABO) issued as Permit No. 11489, 1975 - Bank of Upper Lake). [Additional Reference(s): DWR Levee Log, 2005. USACE Sacramento O&M Manual 506.2, August 1961, (HLM 1.25), Station SA10+00, four 36-inch pipes, dwg no. CC-4-4-29, Index Sheet 4: page 4, 38 of 64 and Sheet 35.1 page 64 of 64]. FS Date: 10/24/2019 12:29:00 PM

Pipe on LS toe.

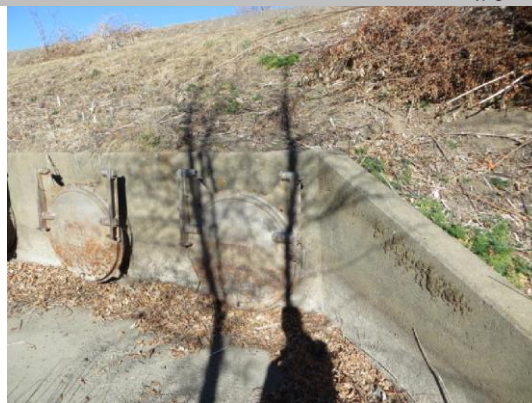
Photo 3 of 3 : UCIP\_FA\_2019\_55786\_51660.jpg

Flapgate on headwall at WS toe.

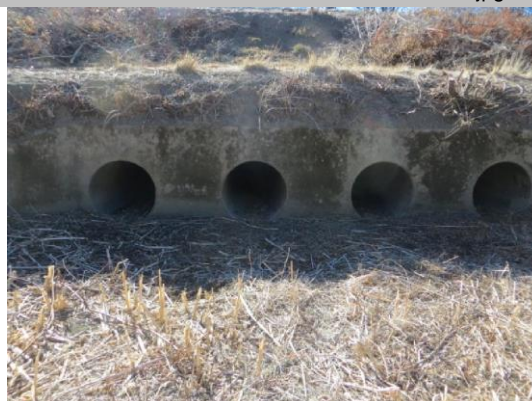
Photo 1 of 3 : UCIP\_FA\_2019\_55787\_51665.jpg

Comment Code						
Inspector Comment						
DS_ID:21237 FS_ID:55787 EP_NO: 11489 Repair Type: Non-Urgent Crossing Status: Found UCIP Comments: 10/24/2019 Record has been updated from No Action needed to Non-Urgent; need to audit record to confirm owner. Crossing has been internally inspected under the DWR DMP Phase 1 project. Inspection report is still not available. (O. Magana - DWR UCIP) FIELD_STRUCT_DESC: 2 of 4: 36-inch corrugated metal drainage pipe through the levee, 15.2 feet below the crown. Flap gate on the waterside (WS) end. Concrete headwalls on both ends. (four 36-inch pipes [HLM 1.25] retained under Automatic Board Order (ABO) issued as Permit No. 11489, 1975 - Bank of Upper Lake). [Additional Reference(s): DWR Levee Log, 2005. USACE Sacramento O&M Manual 506.2, August 1961, (HLM 1.25), Station SA10+00, four 36-inch pipes, dwg no. CC-4-4-29, Index Sheet 4: page 4, 38 of 64 and Sheet 35.1 page 64 of 64]. FS Date: 10/24/2019 12:30:00 PM

Pipe and headdwall on LS toe.

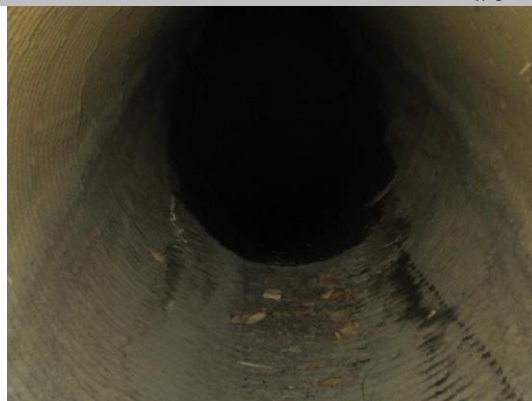
Photo 2 of 3 : UCIP\_FA\_2019\_55787\_51664.jpg

Pipe from LS toe.

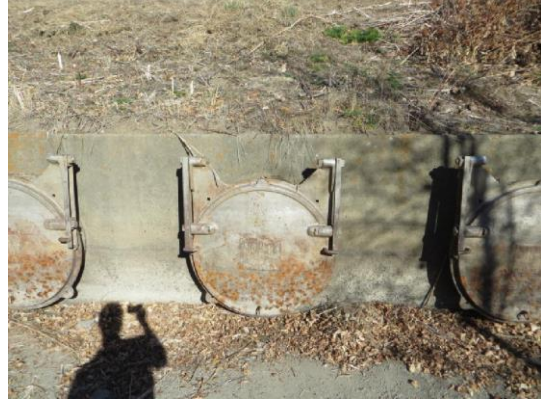
Photo 3 of 3 : UCIP\_FA\_2019\_55787\_51663.jpg

Comment Code						
Inspector Comment						
DS_ID:21237 FS_ID:55787 EP_NO: 11489 Repair Type: Non-Urgent Crossing Status: Found UCIP Comments: 10/24/2019 Record has been updated from No Action needed to Non-Urgent; need to audit record to confirm owner. Crossing has been internally inspected under the DWR DMP Phase 1 project. Inspection report is still not available. (O. Magana - DWR UCIP) FIELD_STRUCT_DESC: 2 of 4: 36-inch corrugated metal drainage pipe through the levee, 15.2 feet below the crown. Flap gate on the waterside (WS) end. Concrete headwalls on both ends. (four 36-inch pipes [HLM 1.25] retained under Automatic Board Order (ABO) issued as Permit No. 11489, 1975 - Bank of Upper Lake). [Additional Reference(s): DWR Levee Log, 2005. USACE Sacramento O&M Manual 506.2, August 1961, (HLM 1.25), Station SA10+00, four 36-inch pipes, dwg no. CC-4-4-29, Index Sheet 4: page 4, 38 of 64 and Sheet 35.1 page 64 of 64]. FS Date: 10/24/2019 12:30:00 PM

Flapgate and headwall on WS toe.

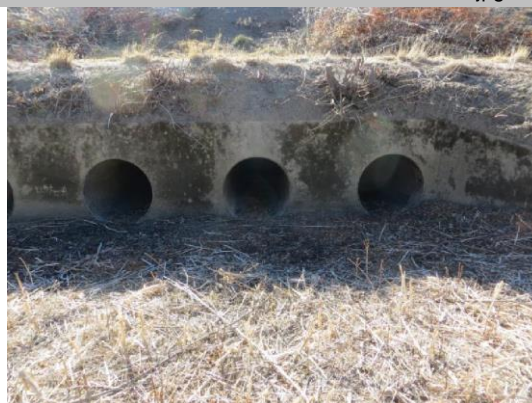
Photo 1 of 3 : UCIP\_FA\_2019\_55788\_51668.jpg

Comment Code						
Inspector Comment						
DS_ID:21238 FS_ID:55788 EP_NO: 11489 Repair Type: Non-Urgent Crossing Status: Found UCIP Comments: 10/24/2019 Record has been updated from No Action needed to Non-Urgent; need to audit record to confirm owner. Crossing has been internally inspected under the DWR DMP Phase 1 project. Inspection report is still not available. (O. Magana - DWR UCIP) FIELD_STRUCT_DESC: 3 of 4: 36-inch corrugated metal drainage pipe through the levee, 15.2 feet below the crown. Flap gate on the waterside (WS) end. Concrete headwalls on both ends. (four 36-inch pipes [HLM 1.25] retained under Automatic Board Order (ABO) issued as Permit No. 11489, 1975 - Bank of Upper Lake). [Additional Reference(s): DWR Levee Log, 2005. USACE Sacramento O&M Manual 506.2, August 1961, (HLM 1.25), Station SA10+00, four 36-inch pipes, dwg no. CC-4-4-29, Index Sheet 4: page 4, 38 of 64 and Sheet 35.1 page 64 of 64]. FS Date: 10/24/2019 12:30:00 PM

Pipe and concrete headwall on LS toe.

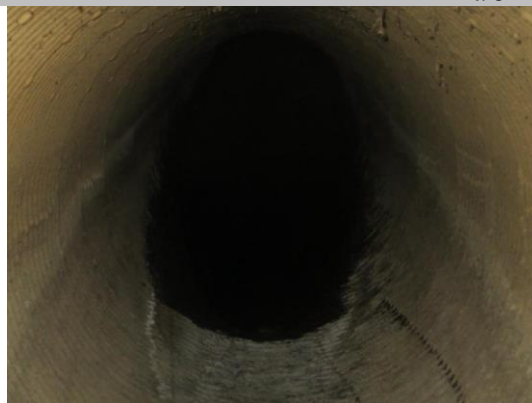
Photo 2 of 3 : UCIP\_FA\_2019\_55788\_51667.jpg

Pipe from LS toe.

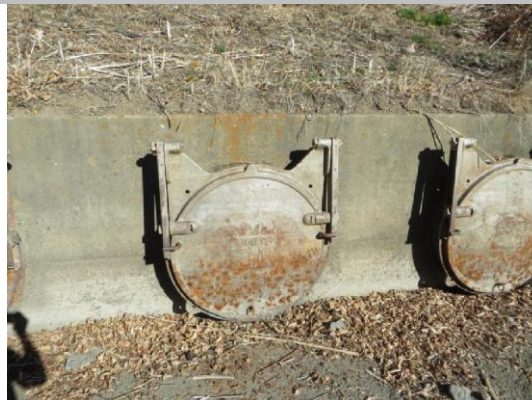
Photo 3 of 3 : UCIP\_FA\_2019\_55788\_51666.jpg

Comment Code						
Inspector Comment						
DS_ID:21238 FS_ID:55788 EP_NO: 11489 Repair Type: Non-Urgent Crossing Status: Found UCIP Comments: 10/24/2019 Record has been updated from No Action needed to Non-Urgent; need to audit record to confirm owner. Crossing has been internally inspected under the DWR DMP Phase 1 project. Inspection report is still not available. (O. Magana - DWR UCIP) FIELD_STRUCT_DESC: 3 of 4: 36-inch corrugated metal drainage pipe through the levee, 15.2 feet below the crown. Flap gate on the waterside (WS) end. Concrete headwalls on both ends. (four 36-inch pipes [HLM 1.25] retained under Automatic Board Order (ABO) issued as Permit No. 11489, 1975 - Bank of Upper Lake). [Additional Reference(s): DWR Levee Log, 2005. USACE Sacramento O&M Manual 506.2, August 1961, (HLM 1.25), Station SA10+00, four 36-inch pipes, dwg no. CC-4-4-29, Index Sheet 4: page 4, 38 of 64 and Sheet 35.1 page 64 of 64]. FS Date: 10/24/2019 12:30:00 PM

Flapgate on headwall at WS toe.

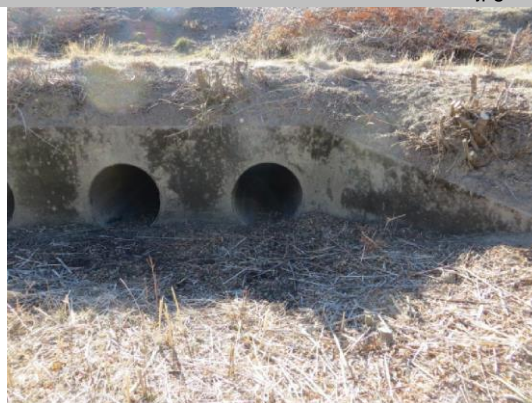
Photo 1 of 3 : UCIP\_FA\_2019\_55789\_51671.jpg

Comment Code						
Inspector Comment						
DS_ID:21239 FS_ID:55789 EP_NO: 11489 Repair Type: Non-Urgent Crossing Status: Found UCIP Comments: 10/24/2019 Record has been updated from No Action needed to Non-Urgent; need to audit record to confirm owner. Crossing has been internally inspected under the DWR DMP Phase 1 project. Inspection report is still not available.(O. Magana - DWR UCIP) FIELD_STRUCT_DESC: 4 of 4: 36-inch corrugated metal drainage pipe through the levee, 15.2 feet below the crown. Flap gate on the waterside (WS) end. Concrete headwalls on both ends. (four 36-inch pipes [HLM 1.25] retained under Automatic Board Order (ABO) issued as Permit No. 11489, 1975 - Bank of Upper Lake). [Additional Reference(s): DWR Levee Log, 2005. USACE Sacramento O&M Manual 506.2, August 1961, (HLM 1.25), Station SA10+00, four 36-inch pipes, dwg no. CC-4-4-29, Index Sheet 4: page 4, 38 of 64 and Sheet 35.1 page 64 of 64]. FS Date: 10/24/2019 12:30:00 PM

Pipe and concrete headwall on LS toe.

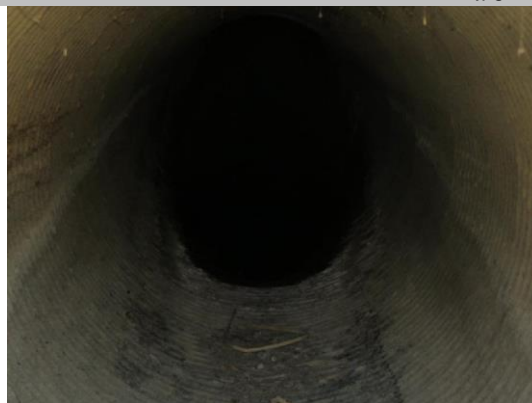
Photo 2 of 3 : UCIP\_FA\_2019\_55789\_51670.jpg

Pipe from LS toe.
